**THE CALIFORNIA EARTHQUAKE OF APRIL 18, 1906**

**REPORT**

**STATE EARTHQUAKE INVESTIGATION COMMISSION**

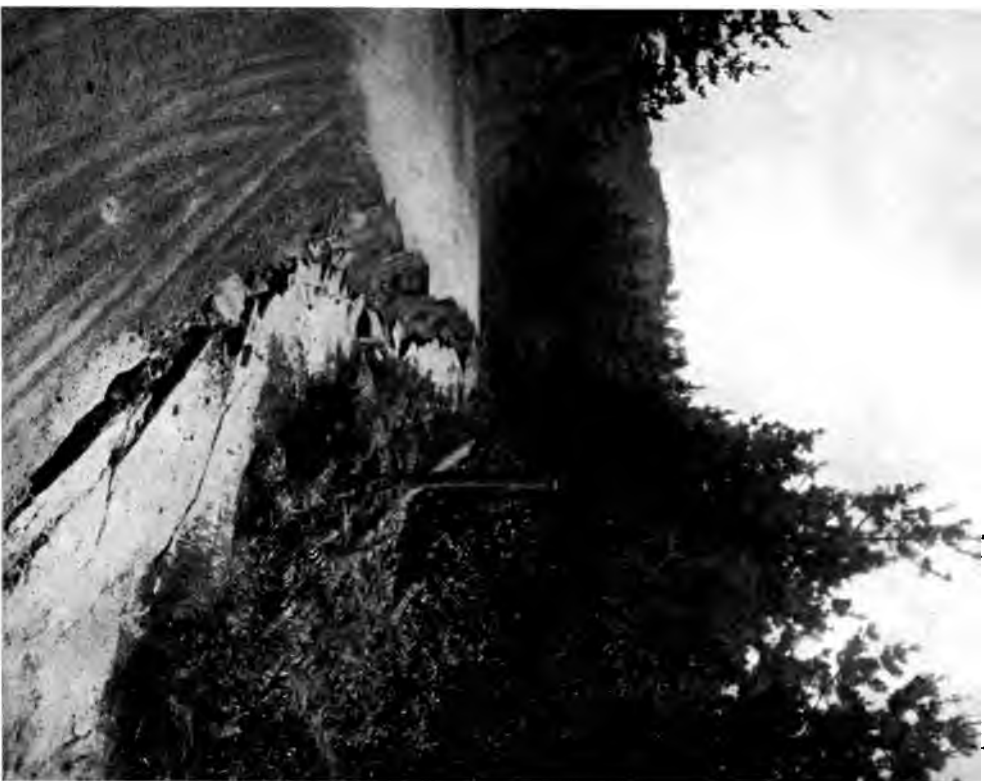
A. Roadside crack 2 miles west of fault, between Inverness and Point Reyes P. O. G. K. G.

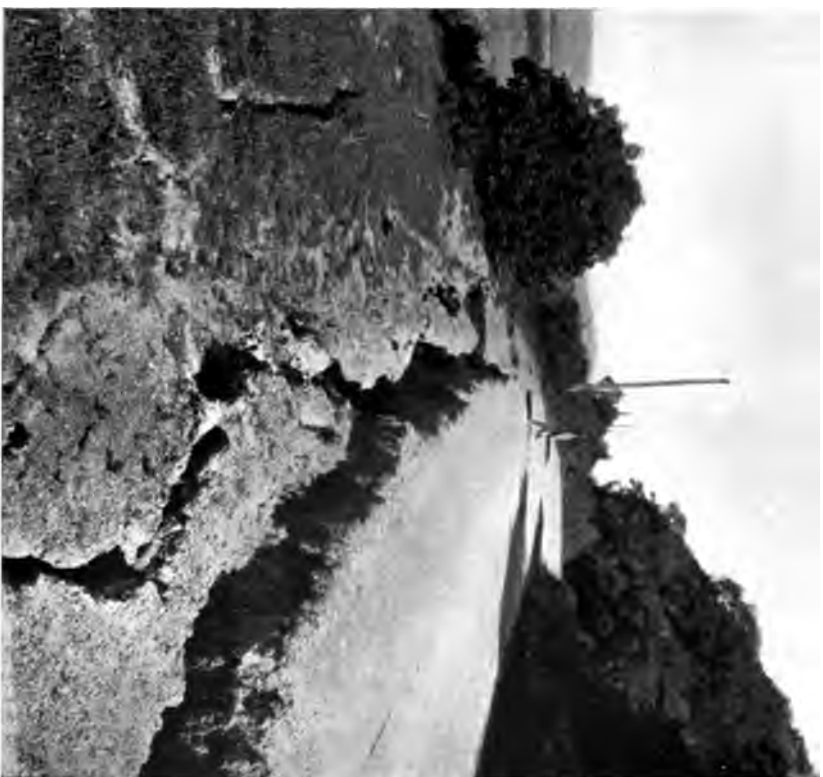
B. Roadside crack a mile southeast of Inverness. G. K. G.

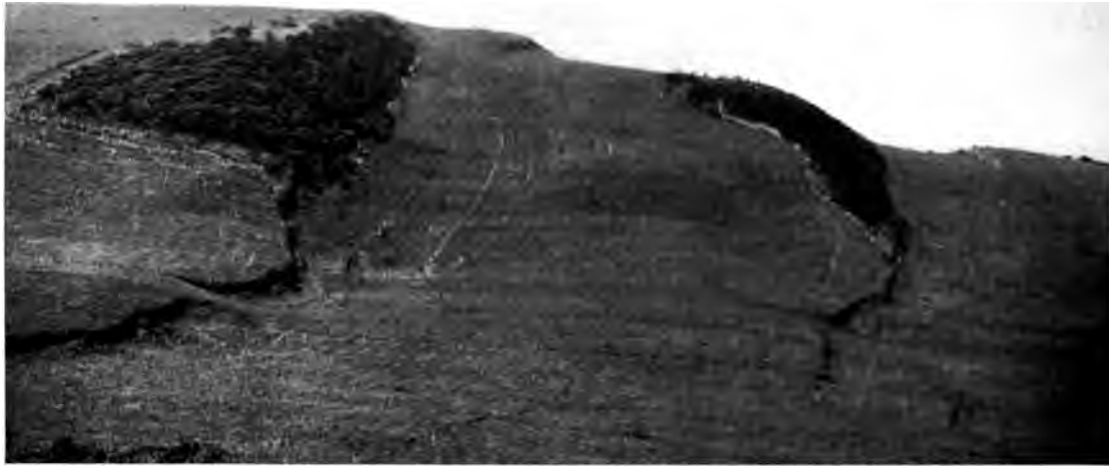
About 6 miles farther south, at the head of Pine Gulch Creek, another road crosses the range, and in following this a group of cracks was seen. A short distance west of the divide, and about a mile in a direct line from the fault-trace, is a fault-sag trending northwest-southeast. On each side of it a crack was seen, the eastern crack being the wider and showing a small throw to the southwest. This crack was traced for about 0.75 mile and found to curve thru an arc of nearly  $90^\circ$  from southeast to southwest. At its southwest end, or at least the southwestern limit of tracing, it is on a ridge, and it there expands into, or else is replaced by, a group of cracks diverging fan-wise. On each member of the group faulting took place, the downthrow being toward the northwest except in the case of two apparently short cracks with downthrow to the southeast. On four of these cracks the throw was greater than 1 foot, and at one place it was about 5 feet. Each crack was associated with a preëxistent bluff or scarp, indicating that earlier movements have occurred at the same place. The field in which the principal phenomena occur is cultivated with the exception of the steeper scarps, whose faces retain a bushy growth. (See plates 52A and 53A.)

A. Group of earthquake cracks southwest of head of Pine Gulch Creek. Looking southwest. Structure well indicated by sky line. Since dislocation field has been plowed and farm road graded up fault-scarps. Compare Plate 53 A. G. K. G.

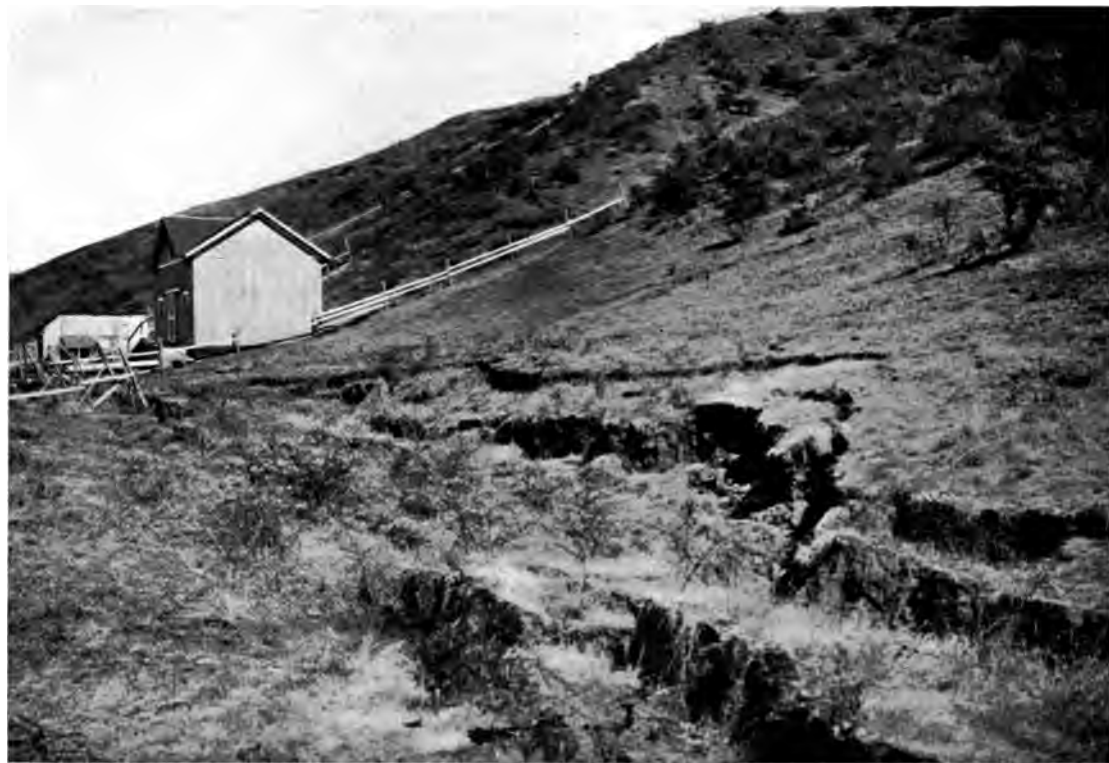
B. Earthquake cracks in Bolinas at edge of an earthquake sag. G. K. G.

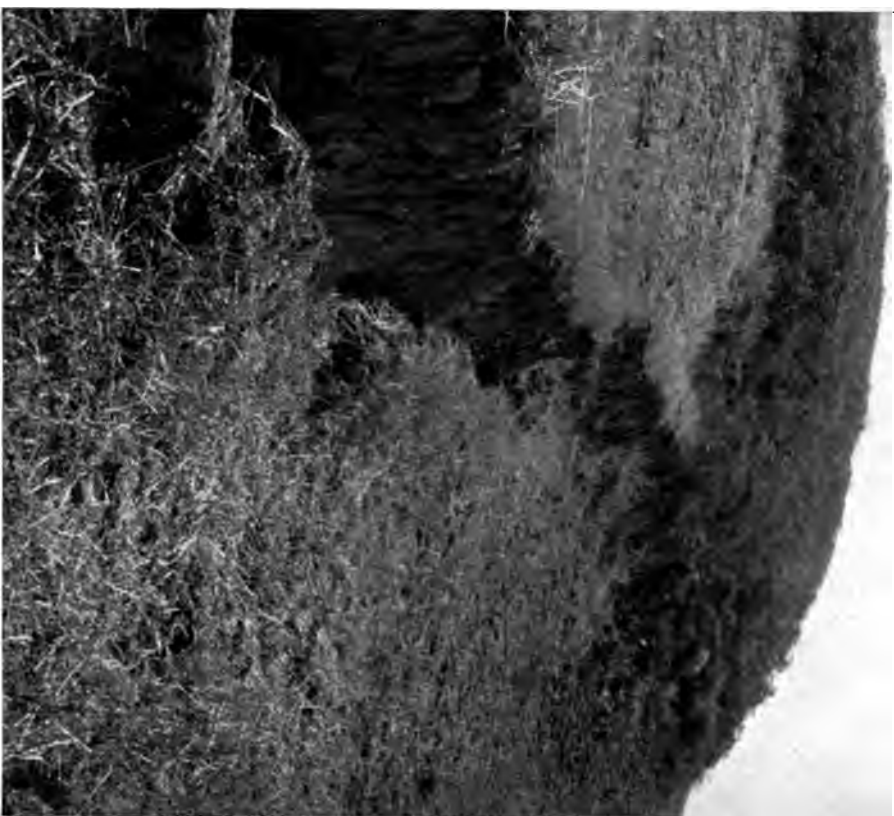
**A. Fault-scarp on earthquake crack. Throw is about 5 feet. Compare Plate 52 A. G. K. G.**

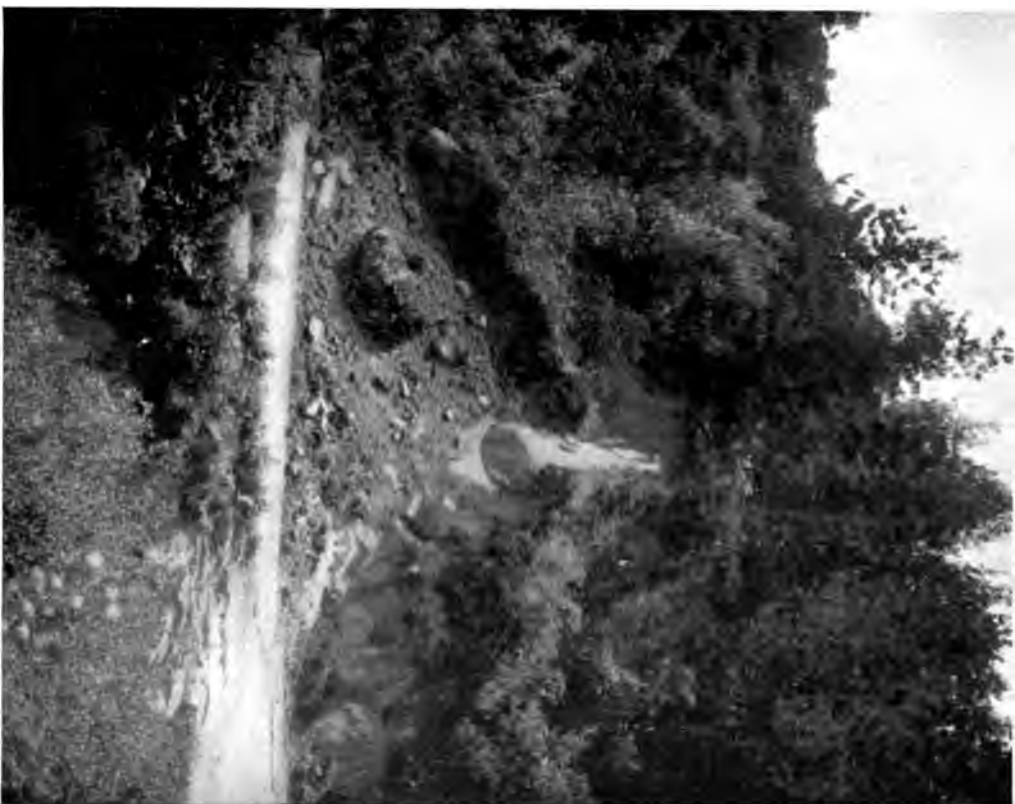
There were many landslides of the dry type on hillsides, masses of earth and rock breaking away on steep slopes and tumbling to the bottom. The largest seen were on the high ridge west of Tomales Bay, in the vicinity of Sunshine Ranch. Closely related to these were small falls of earth and rock from the low cliffs created in the construction of side-hill roads. (Plate 53B.) They occurred at a few places within the Rift and

**B. Landslide from road-cliff about two miles west of Inverness. Slide occurred at time of earthquake. G. K. G.**

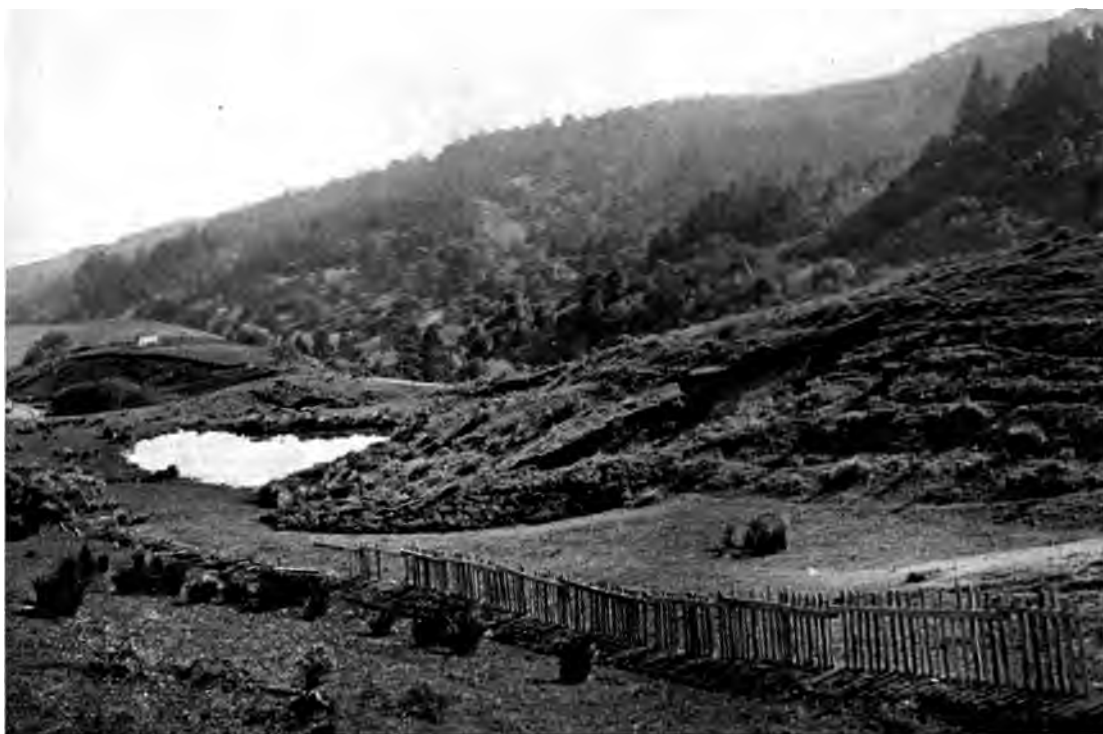
A. Landslide 4 miles northwest of Bolinas Lagoon. Looking south-southwest. Slide encroaches upon a rift pond, caused directly by rains early in 1907, indirectly by earthquake of 1906. G. K. G.

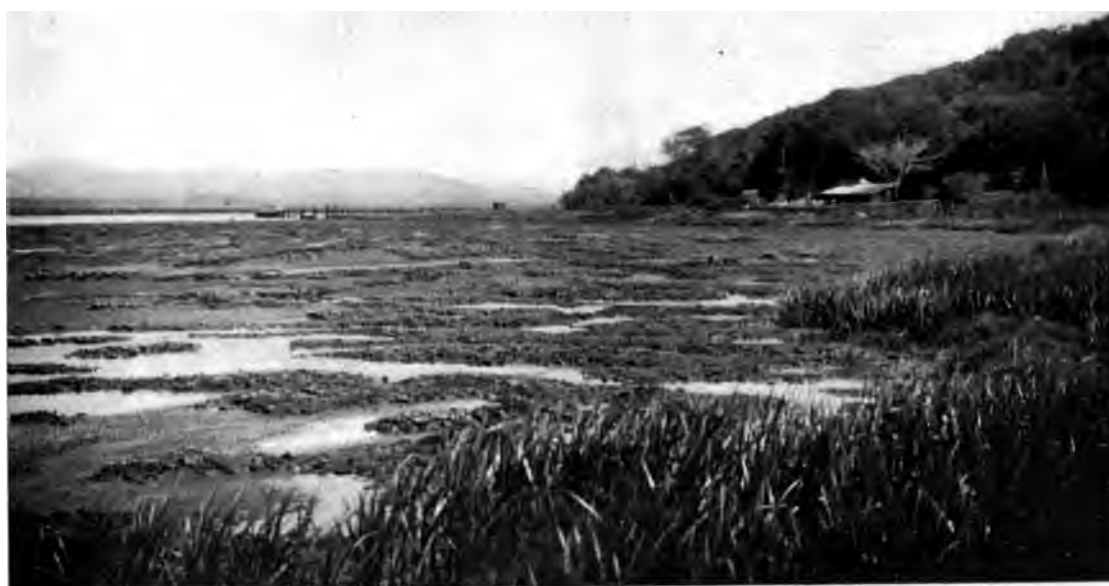
When the tidal mud was first seen after the earthquake, it was observed to be covered with ridges and troughs. (Plate 54B.) This corrugation was gradually smoothed out by the action of the waves (plates 55B and 56A), so that at the expiration of a year its expression was largely lost, tho a few of the larger ridges could still be traced, and much of the plain retained a pattern imprest on it by the ridging. It is probable that the entire tract of tidal mud was thus affected, altho the ridges were not seen on the area lying nearest to the east shore. That area did not come under observation until after the spring floods

B. Ridged mud plain 1 mile from Inverness. Looking east-southeast. Mr. Hamilton's barn at right. April 28, 1906. Tide is low. Pools occupy the deeper troughs. G. K. G.

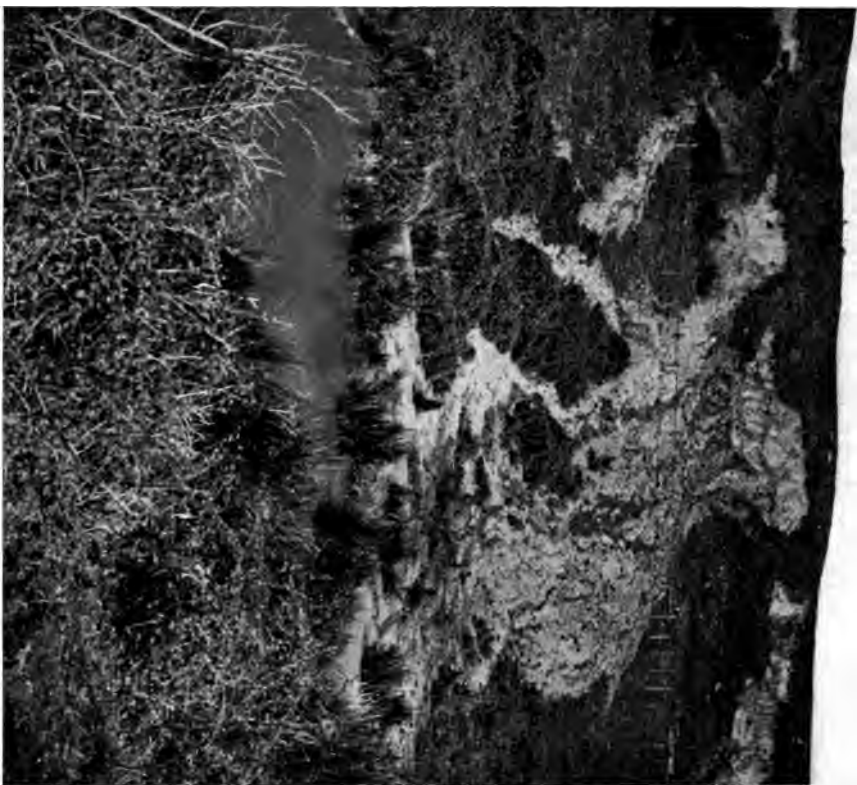
A. Landslides 2.5 miles northwest of Bolinas Lagoon. Looking northeast. Storm waters of 1907, gulled by earthquake cracks, converted earth into soft mud. G. K. G.

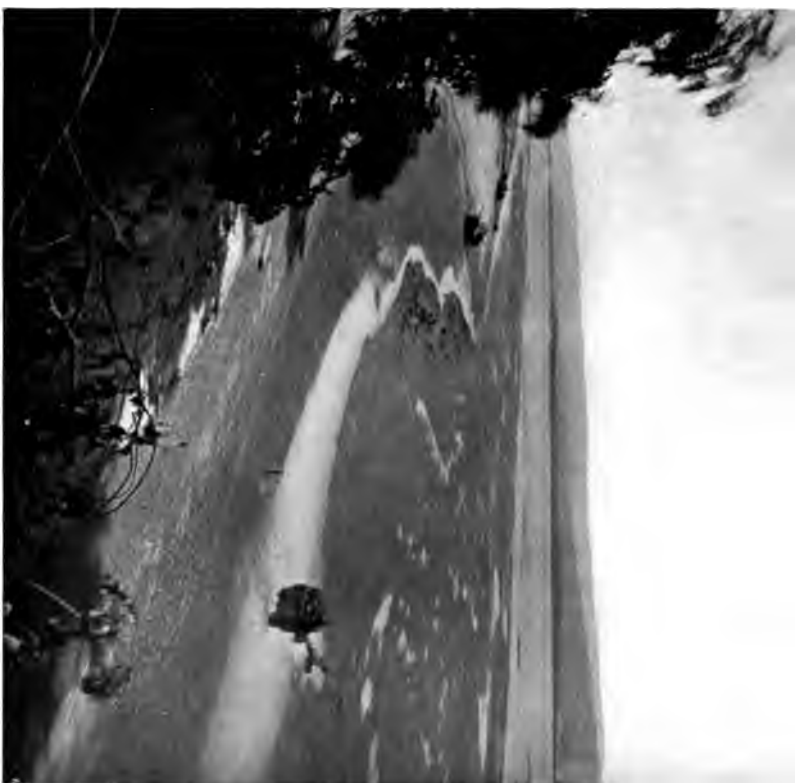
B. South part of Inverness shoal, at low tide, April 28, 1908. Looking north-northwest. Lane of water separates firm, gravelly beach from mud shifted shoreward by earthquake. G. K. G.

At various places along the shore, from Inverness to a point 1.5 miles southward, the tidal mud seemed to be crowded against the firmer ground at the shore, being pushed up in a ridge, as shown in the accompanying photograph. (Plate 55B.) Two piers at Inverness, light wooden structures, resting on piles and extending out several hundred feet from the shore, were telescoped. (Figs. 26 and 27.) In the case of Martinelli's pier the telescoping was shown by the inclination given to piles at the landward and bayward ends, from which it appears that the ground in which the piles were set was crowded together, so that the foundation of the pier was shortened, while the superstructure resisted shortening. The resistance was temporary only, for before the agitation ceased the pier was broken in two; and the inclination of the piles is supposed to have been given during the early stages of the tremor. Coincident with the movement of the

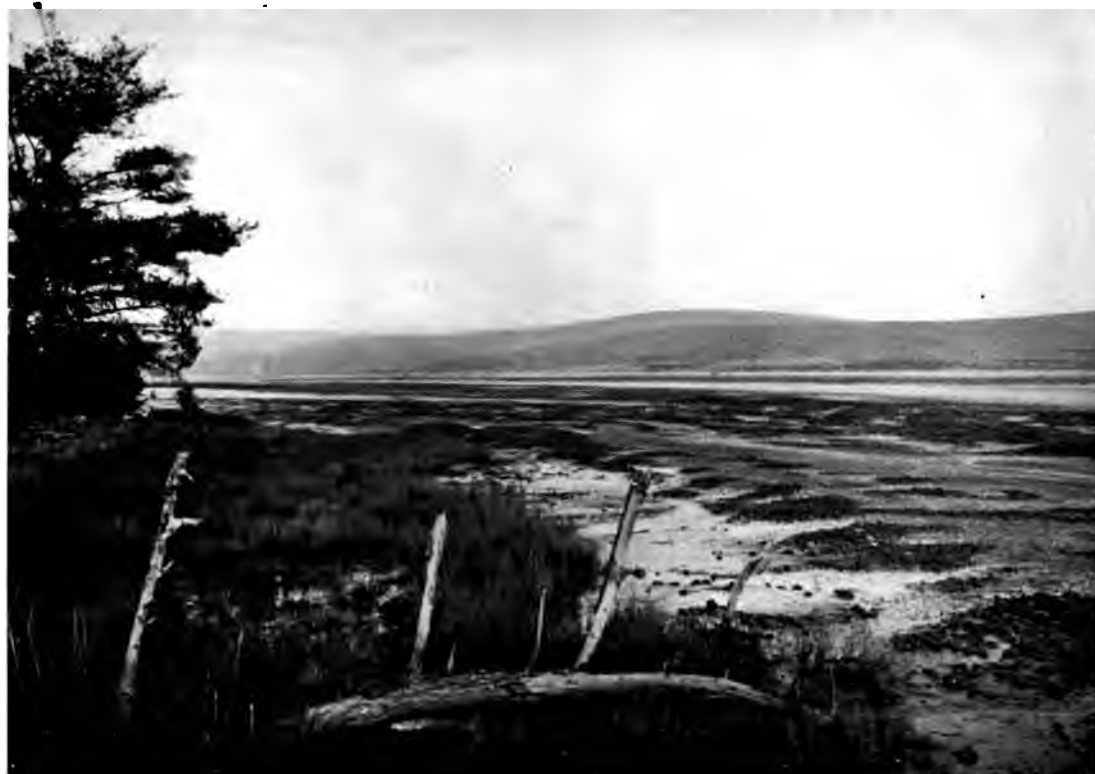
A. Ridges caused by earthquake on tidal flat of Tomales Bay, 1 mile south of Inverness. Looking north. December, 1906. G. K. G.

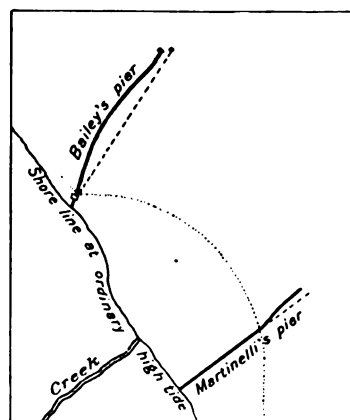
FIG. 26. — Sketch of Inverness piers. Full lines show positions of piers after earthquake; broken lines show positions before earthquake. Dotted line shows shoreward limit of the shifting of bottom.

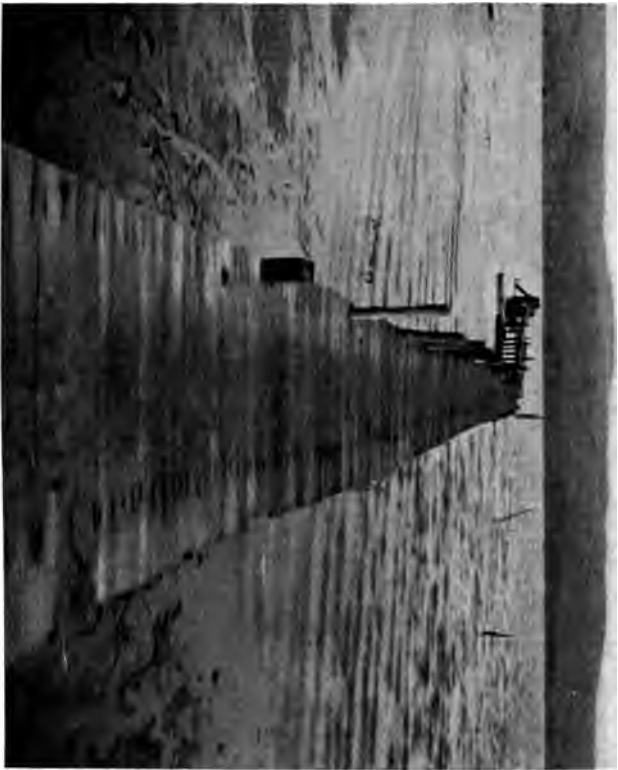
A. Martine's pier at Inverness. Originally straight; shifted and broken by earthquake. Repaired before photograph was taken. G. K. G.

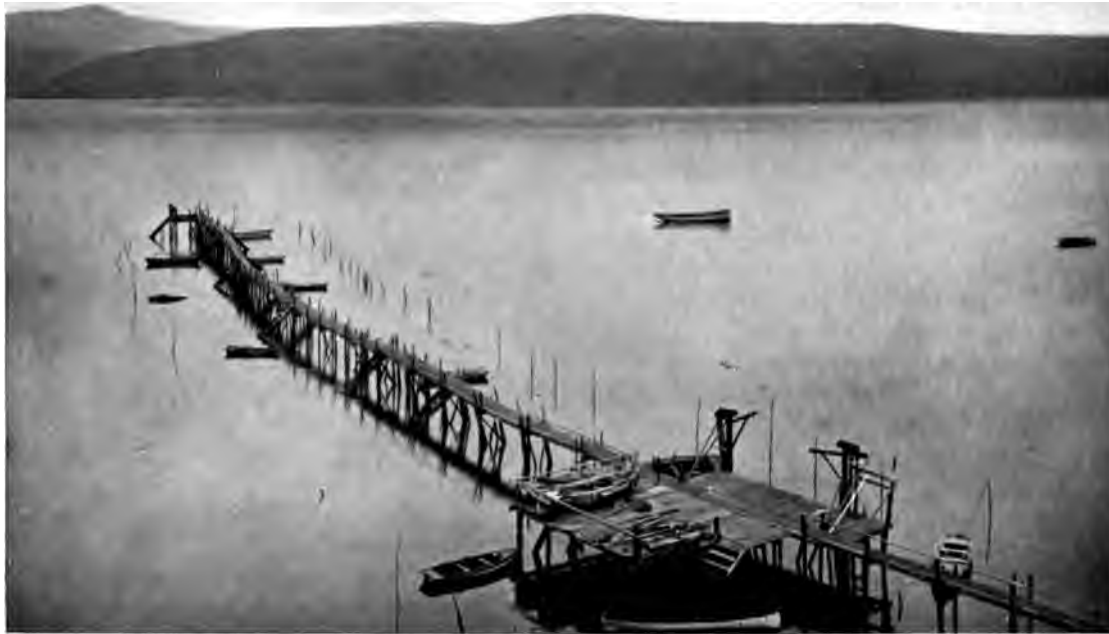
A. Bailey's pier at Inverness. Another view, position of camera being approximately same as in making photograph below, taken before the earthquake. G. K. G.

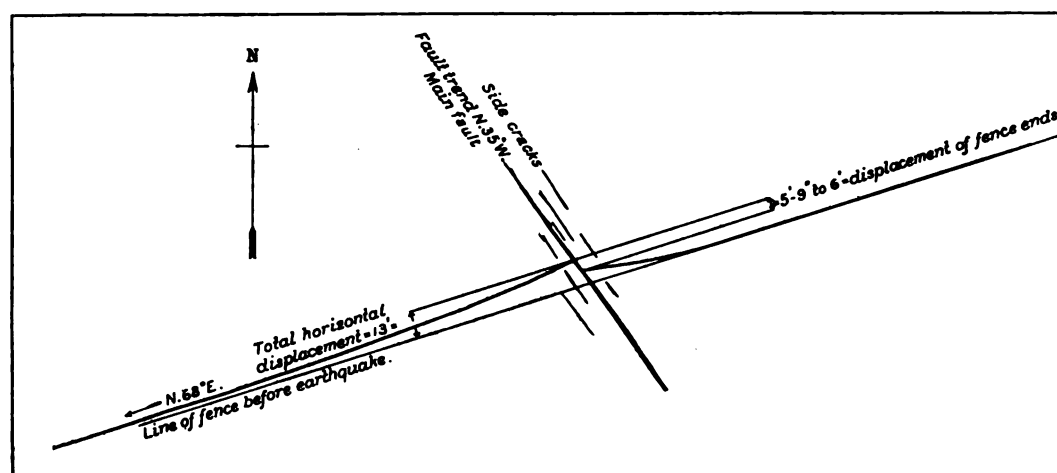
FIG. 29. — Offset fence southeast of Mussel Rock, showing distribution of deformation on either side of fault.

Still farther to the southeast, about 1.25 miles, the fault intersected a fence and not only caused it to be offset, but the intersection showed clearly the effect of the drag in the earth movement. The bearing of the fence is  $N. 68^{\circ} E.$ , so that it is approximately transverse to the line of the fault. On the west side of the latter, the fence suffered a displacement to the northwest of 13 feet from its former position, and this displacement was effected by a bending or curvature in the fence line extending westerly from the fault for a distance of over 200 feet. On the east side of the fault, the fence was bent away from its former position, *in the same direction*, about 7 or 7.25 feet, the bent portion extending easterly from the fault-trace about 45 feet. The two ends of the fence were thus offset on the line of the fault only 5.75 to 6 feet, altho the total displacement was 13 feet. The displacement is shown diagrammatically in fig. 29. At a point 330 yards beyond this, on the Rift, the fault-trace was found to be confined to a furrow about 6 feet wide, passing thru a little trough between an outcrop of Franciscan on the west and a fine conglomerate (Merced) on the east.

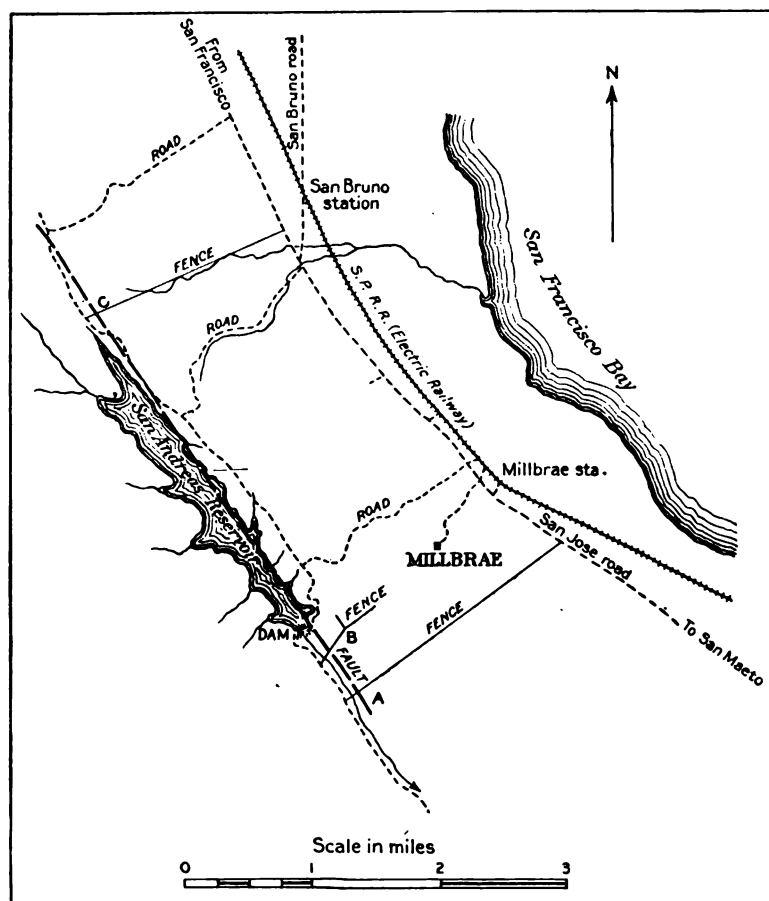
FIG. 30.—Index map showing positions of three fences, A, B, and C, the offsets of which are shown in figs. 31, 37, and 38.

The index map, fig. 30 (p. 95), indicates the position of three dislocated fences which were surveyed by R. B. Symington, C.E. The fences are marked A, B, C. One of these fences, C, near the upper end of San Andreas Lake, is nearly normal to the trace of the fault, and its deformation extends over a zone 1,200 feet wide, the total displacement aggregating 16.9 feet. Here, as usual, the portion on the southwest side of the fault moved relatively to the northwest, but there was a distinct drag on the northeast side in the same direction. (See fig. 31.)

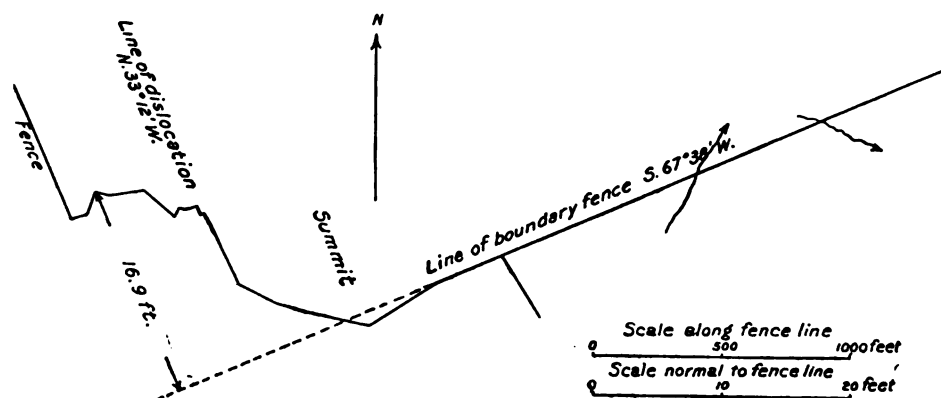
FIG. 31. — Fence C of fig. 30.

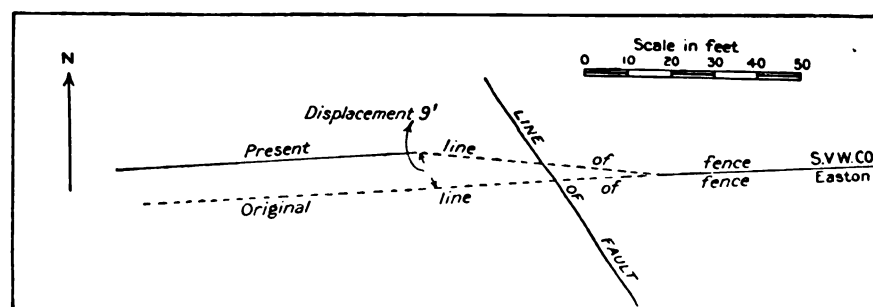
FIG. 32. — Dislocation of fence near San Andreas Lake. After H. Schussler.

The offsets in three other fences southeast of San Andreas Lake are shown in figs. 32, 33, and 34 and plates 60d and 61b.

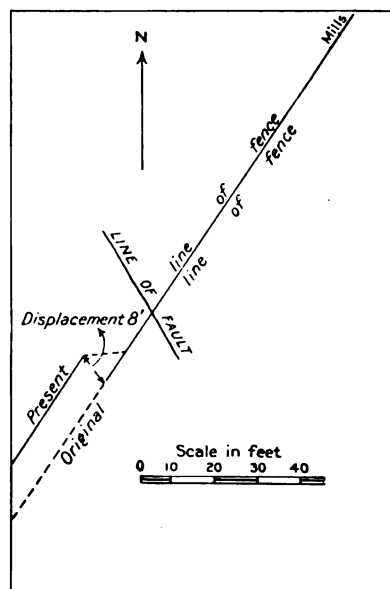
FIG. 33.—Dislocation of fence near San Andreas Lake. After H. Schussler.

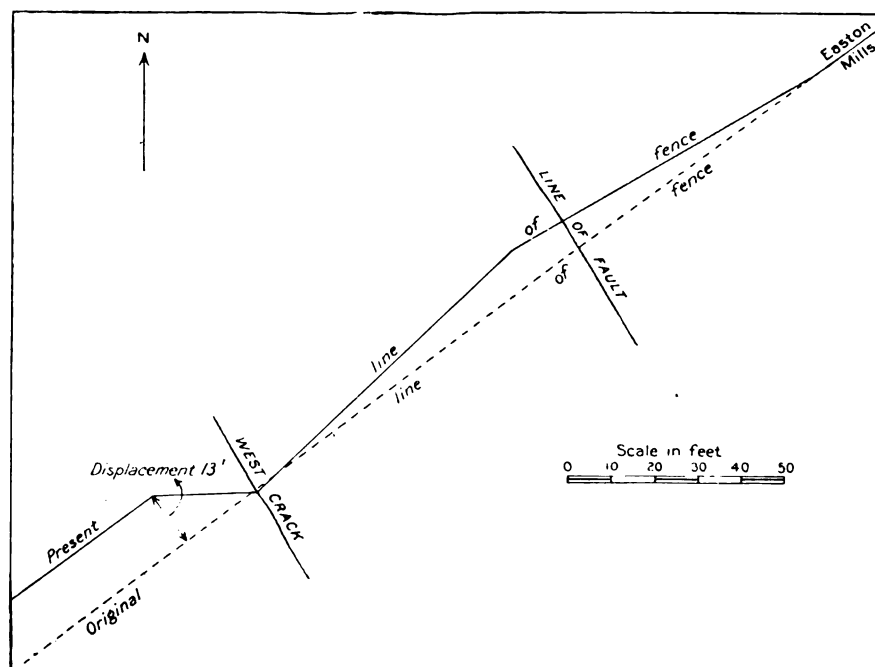
FIG. 34.—Dislocation of fence near San Andreas Lake. After H. Schussler.

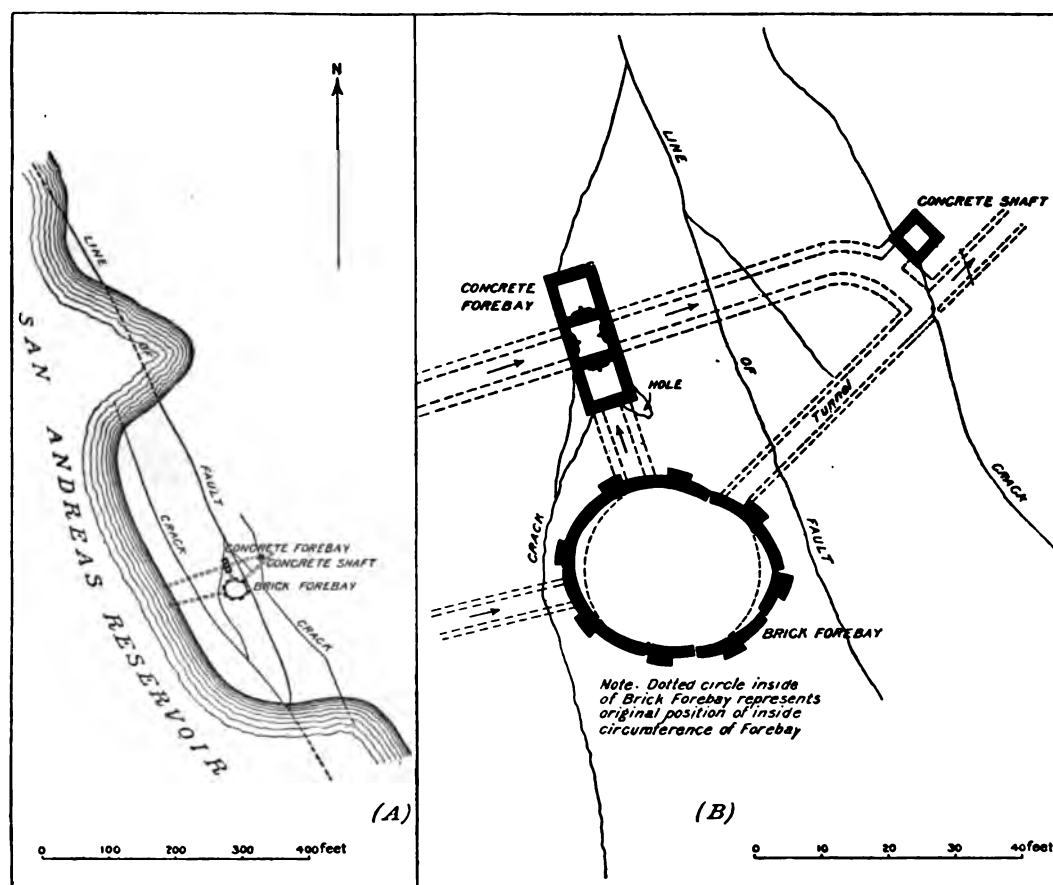
FIG. 35.—Main and auxiliary faults, San Andreas Lake. A. General Plan. B. Detail. After H. Schussler.

The walls are about a foot thick, and are strongly buttressed. As a result of the shock this gate-well was shattered and deformed so that it became oval in cross-section, the east and west diameter becoming 30 feet and the north and south diameter about 21 or 22 feet, as shown in the accompanying figure. A new concrete gate-well a few feet to the north, rectangular in cross-section and having three compartments, each  $2.5 \times 2.5$  feet, was uninjured, altho on the line of the same branching crack. A concrete manhole 45 feet northeast of the damaged gate-well, also on an auxiliary crack, was similarly unaffected. (See fig. 35.)

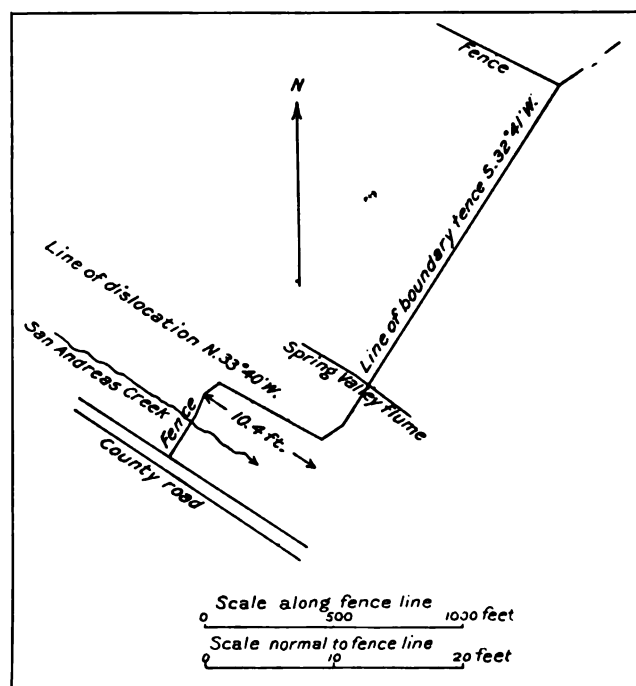
FIG. 37.— Fence B of fig. 30. Dislocated by fault.

between the estate of D. O. Mills and the property of the Spring Valley Water Company, causing an offset of about 10 feet. Here the deformation of the fence was distributed over a zone 300 feet wide in the direction of the fence, or about 250 feet in a direction normal to the trace of the fault. A survey of the dislocated fence made by R. B. Symington, C.E., is shown in fig. 37. Half a mile below the dam, the fault again crost the Pilarcitos pipe. A note by Mr. Anderson as to the conditions at this intersection is as follows:

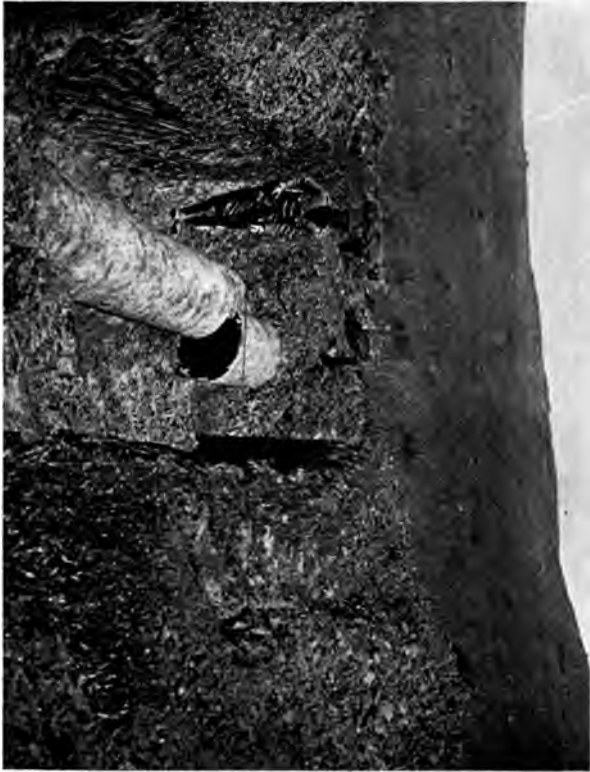
At a point about a mile from the upper end of San Andreas Lake, the fault intersects a bend in the pipe at two places, and here again the pipe was telescoped. (See plate 60A.) The conditions at one of these intersections are thus described by Mr. Robert Anderson:

The pipe makes an angle of about  $15^\circ$  with the fault-trace, the end of the pipe on the north side of the fault running that much nearer the north. The ends of the pipe on opposite sides of the fracture were therefore thrust into each other. The furrow was at this place divided into several smaller ones, the disturbed zone covering an area of considerable width. The pipe was broken in three places within 100 feet. In one place it was telescoped 58 inches, as shown in plate 59B; in another 17 inches, and in a third, the one farthest north, 41 inches.

A. Offset in 30-inch water-pipe by fault. Northwest of San Andreas Lake. A. C. L.

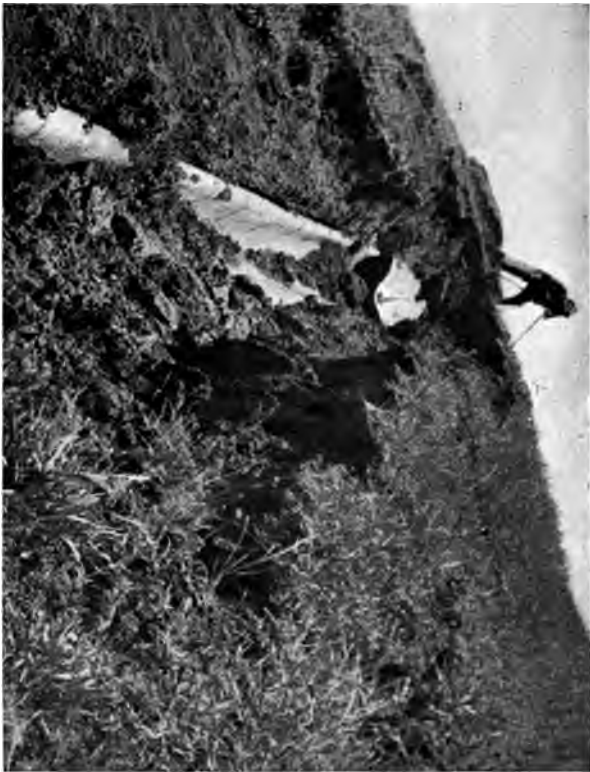
About 2 miles from the upper end of San Andreas Lake the fault encounters the 30-inch, laminated, wrought-iron pipe of the Spring Valley Water Company, which prior to the earthquake conveyed the water from Pilarcitos Lake to San Francisco. The metal of the pipe is about 0.1875 inch thick and coated with asphaltum. The pipe is buried in the soil at a depth of 3 to 4 feet. The point of intersection is near Small Frawley Canyon. Here the course of the pipe swings from a northwesterly to a more northerly course, and the fault consequently intersects it at an acute angle. At the point of intersection, the pipe was obliquely sheared apart and telescoped upon itself, effecting a shortening of about 6 feet. The amount of the transverse offset involved in the shear was about half the diameter of the pipe. The portion north of the break was moved east and telescoped southerly. For 0.875 mile southeast of this point, the path of the fault lay on the northeast side of the pipe and nearly parallel to it, but a short distance away. About 220 yards southeast of the intersection, where the pipe, buried a few feet below the surface, ascends a rising slope, the pipe had completely collapsed for a distance of several

yards, due doubtless to the establishment of a partial vacuum within the pipe by the sudden withdrawal of the water from the arch in the pipe at the time of the shock, owing either to the leakage below, or the propulsion of the water induced by the shock. (See plate 60B.)

F. Collapse of 30-inch water-pipe northwest of San Andreas Lake. R. L. H.

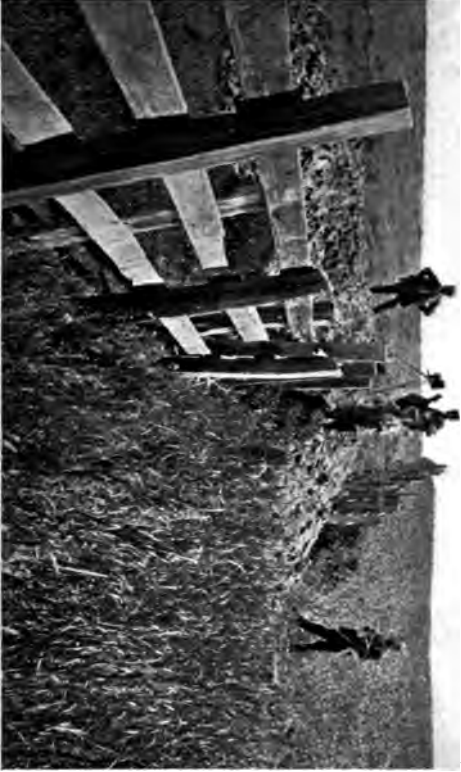
furrow. The movement was in the same direction as before, therefore a pulling apart of the pipe took place instead of a compression. There occurred two breaks in the pipe (see plate 59A), the main one at the crossing of the fault, and the other 150 yards away on the northeast side of the fault, but very near it, the pipe being almost parallel with it. At the main break, the pipe was pulled apart 59 inches, and at the other one 21.5 inches, making a total displacement of 6.666 feet. The pipe was not quite parallel with the fault and therefore there was a slight offset, at right angles to its direction, of 4 inches at the main break and 2 inches at the minor one, or a total of 6 inches. A fence which crossed the fault at the main break is offset 6.5 feet. (Plate 60c.)

Q. Offset of 6.6 feet in fence, northwest of San Andreas Lake. R. L. H.

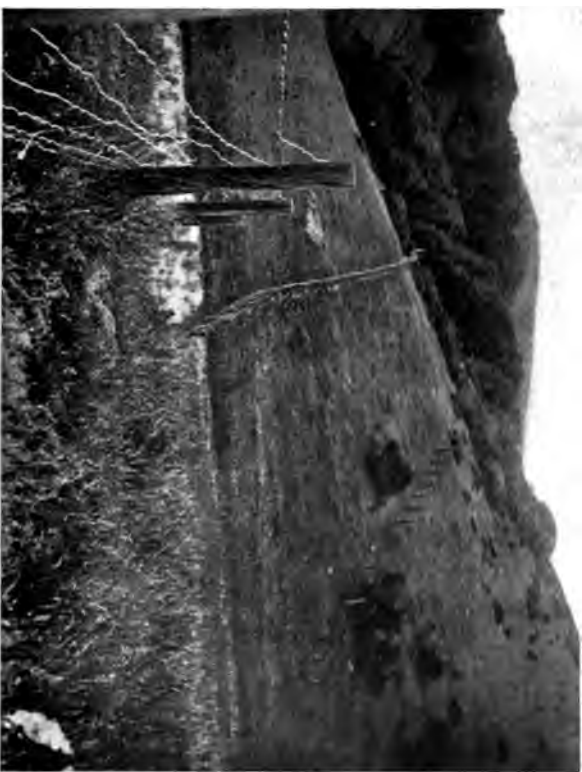
D. Offset of 6 feet in fence between San Andreas and Crystal Springs Lakes. Per J. O. B.

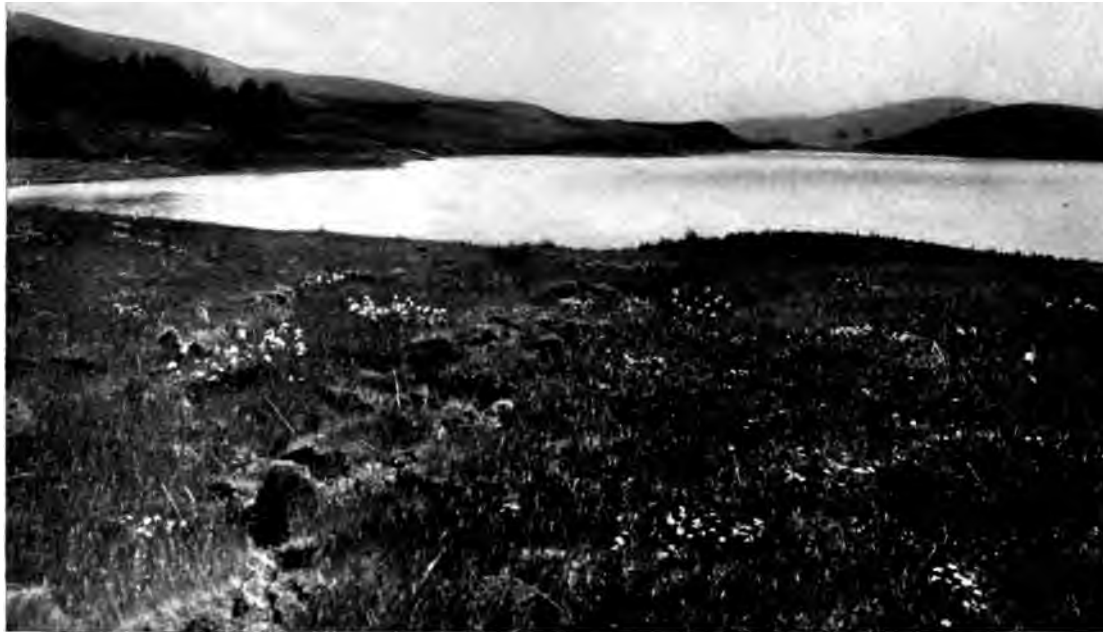
lake for the first 0.875 of a mile of its length. It then enters the water (plate 61D) and follows the northeast side of the lake, a little distance from shore, to the San Andreas dam at the lower end of the lake. In this distance of nearly 2 miles, the fault-trace emerges from the water at a number of points where little capes project into the lake. The crossing of these capes by the fault-trace indicates that it follows a very straight course beneath the water of the lake. On the last of these promontories traversed by the fault, the main fault-trace has associated with it a number of auxiliary cracks. Between the main fault-trace and one of the diverging cracks, on the southwest side of the fault, is a brick and cement gate-well in connection with the tunnel which takes the waters from the lake toward Millbrae. This gate-well was circular in cross-section, the inside diameter being about 26 feet. The nearest point of the structure to the main fault-trace is within 5 feet.

A. Fault-trace where it passes into San Andreas Lake. D.

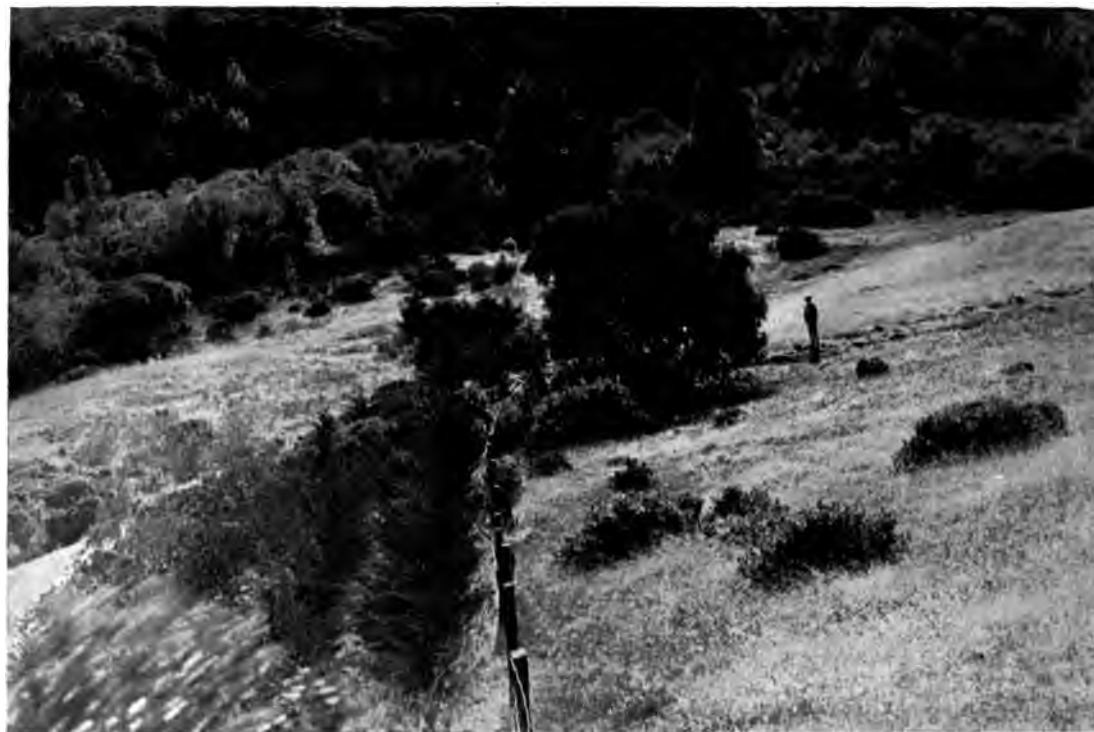
B. Offset fence near Crystal Springs Lake. R. A.

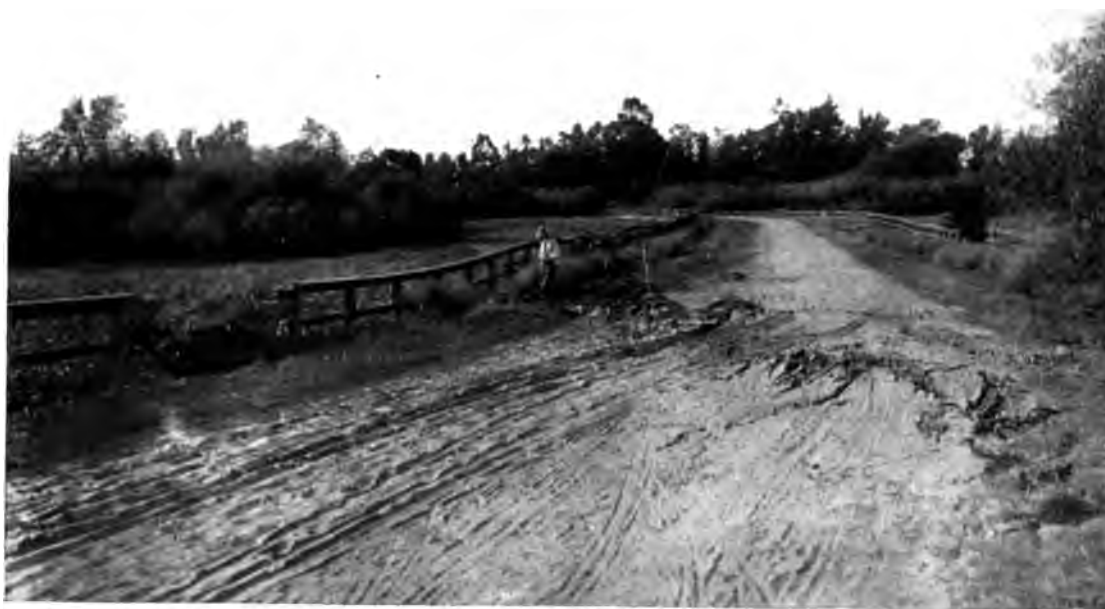
B. Offset of road by main fault near Searsville reservoir. Per J. C. B.

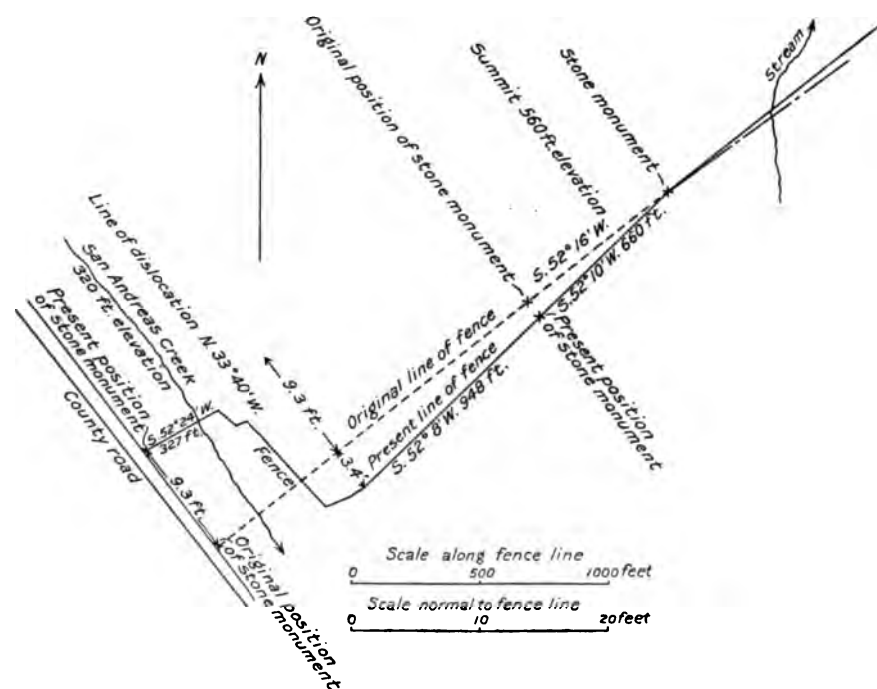
In this neighborhood the fault crost a wire fence nearly normally, the line of which had been carefully established by a series of stone monuments. The fence marks the boundary between the estates of D. O. Mills and A. M. Easton. The deformation of the fence as shown in the accompanying diagram, fig. 38, from a survey by R. B. Symington, C.E., extended over a zone at least 2,200 feet wide. On the southwest side of the fault-trace, the fence was displaced to the northwest a distance of 9.3 feet, and on the northeast side it was displaced to the southeast 3.4 feet, making a total displacement of 12.7 feet and showing a slight drag close to the line of the fault. There were two parallel cracks representing the fault about 90 feet apart, and the chief displacement took place on the west crack.

FIG. 38. — Fence A of fig. 30. Dislocated by fault.

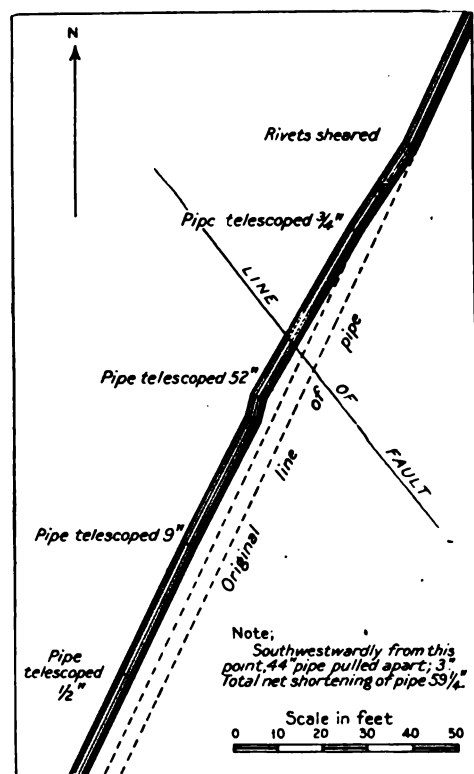
Just above the northern end of Crystal Springs Lake, a 44-inch water main made of iron 0.125 inch thick runs up the hill from the lake valley in a direction about N. 28° E. This line is buried all the way under several feet of soil. The fault crosses it at the base of the hill, in its N. 37° W. course, thus making an acute angle of 65° with the pipe line. At the intersection of the fault and the pipe line, the heavy rivets of the pipe were torn out all the way around at a section joint and the two sections were jammed into one another a distance of 4 feet 4 inches. In addition to the telescoping of this pipe, a slight change in course was induced, so that the northeast end trended one or two degrees more toward the east than the other end. This was shown by the fact that the broken ends did not fit into each other squarely. There was no lateral displacement, the whole movement having been taken up by the telescoping, but there was a bending of the pipes at the point of the break, as mentioned. The main part of the pipe, at a distance from the fault, must have moved with the land. At the fault-trace there was a bend amounting to one or two degrees. Supposing the bowing to be simple, this amount indicated that the land must have carried the pipe the distance represented by the telescoping, or about 10 feet, within 300 to 500 feet

of the fault on one side, and that beyond such a point the pipe must have preserved its normal course. As a matter of fact, this same pipe was broken on the northeast side of the fault about 400 feet further up the hill. The break occurred at the junction of 2 sections, the rivets having been sheared off and part of the rim torn away at the rivet holes. The ends were pulled apart 3.375 inches. Here the pipe resumed its former course, but owing to the slight amount of the pipe displayed by the excavation, it was impossible to see whether a return bend occurred or not. Beyond the break the direction was as before measured, approximately N. 28° E. No such break occurred on the southwest side of the fault. A crack was formed in the earth at right angles to the pipe for several yards on either side of the break.

The measurements of the engineers of the Spring Valley Water Company on the break and displacement of this pipe at the intersection above described by Mr. Anderson are given in the accompanying diagram, fig. 39.

FIG. 39.—Intersection of fault and Locks Creek pipe. After H. Schussler.
